CHRONOLOGY

CONDITIONS

**DENDROCHRONOLOGICAL STUDY OF THE
GLENBURN STORE
Riverdale, Morris County, NJ**

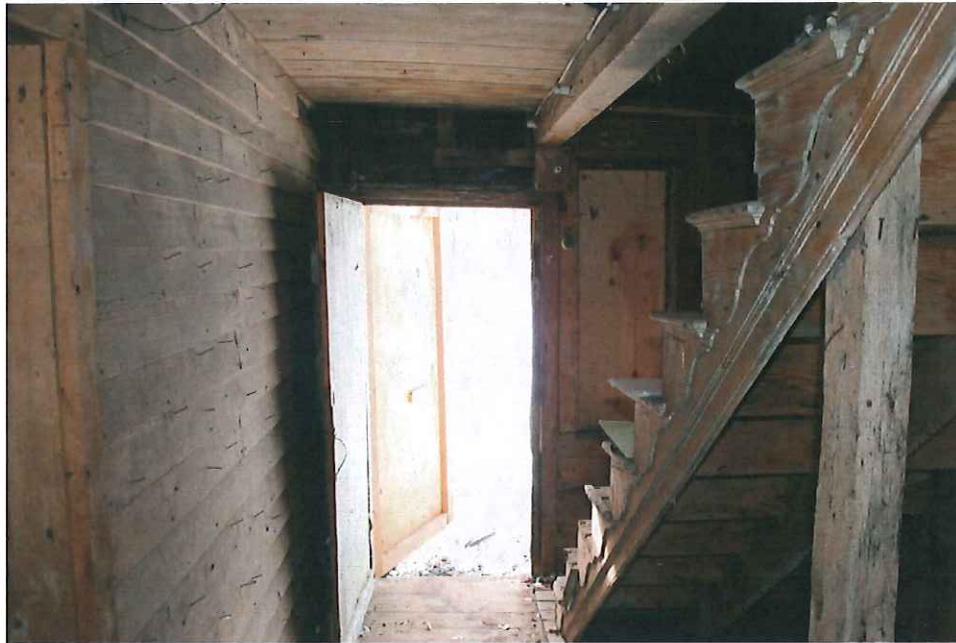
The south wall of Room 101 is finished with clapboards and appears to have been the original exterior wall of this section of the building. The clapboards are installed with cut nails that exhibit little deterioration indicating that this area (the hall) might have been enclosed at an early date or might have always been under a porch. There is a distinct change in the east and west wall framing between Room 101 and 102, which could reflect the addition of Room 102, or could simply be a result of the addition of doors at the east and west ends of the hall. If this space were entirely added later, as opposed to enclosing a porch, it is difficult to explain the continuous rafter plate, which spans entirely across Rooms 101 and 102. Additional evidence that Room 101 was originally an exterior space is the abandoned butt hinge mortises at the exterior of the door on this wall indicating a screen or storm door. Given this evidence, we believe the early configuration of Rooms 101/102 was that the second floor extended over Room 101, which was originally an open porch that was later enclosed.

Photo 5: Room 101 (Hall) facing west. The wall at left appears to have been the original exterior wall of the first section of the building, however the rafter plate is continuous across both of these sections of the building. The stair does not appear to be original to this section. (1/17/13)

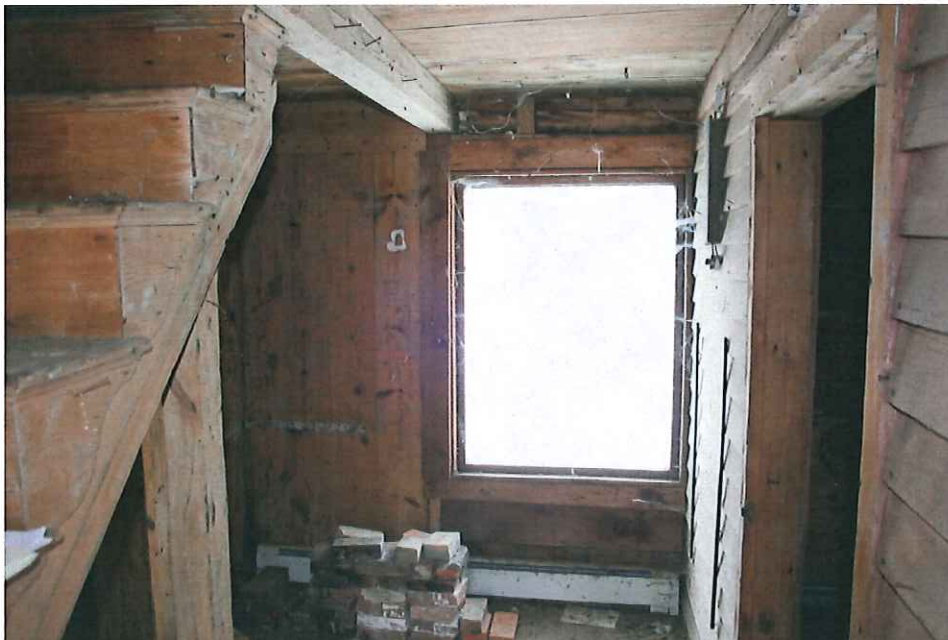
Photo 6: Room 101 (Hall) facing east. This window had been a door. The walls, ceiling and trim in this space have been sandblasted. (1/17/13)

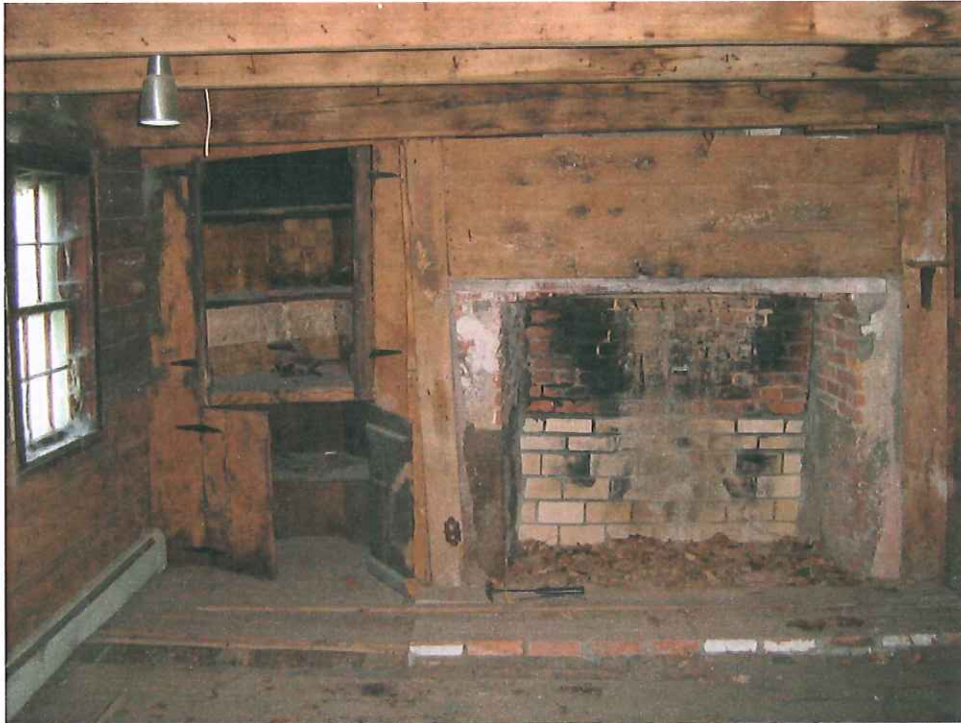
Photo 7: Room 102 facing south showing fireplace and original millwork, which has all been sand blasted. Room 102 appears to be the earliest section of the building. (10/5/12)

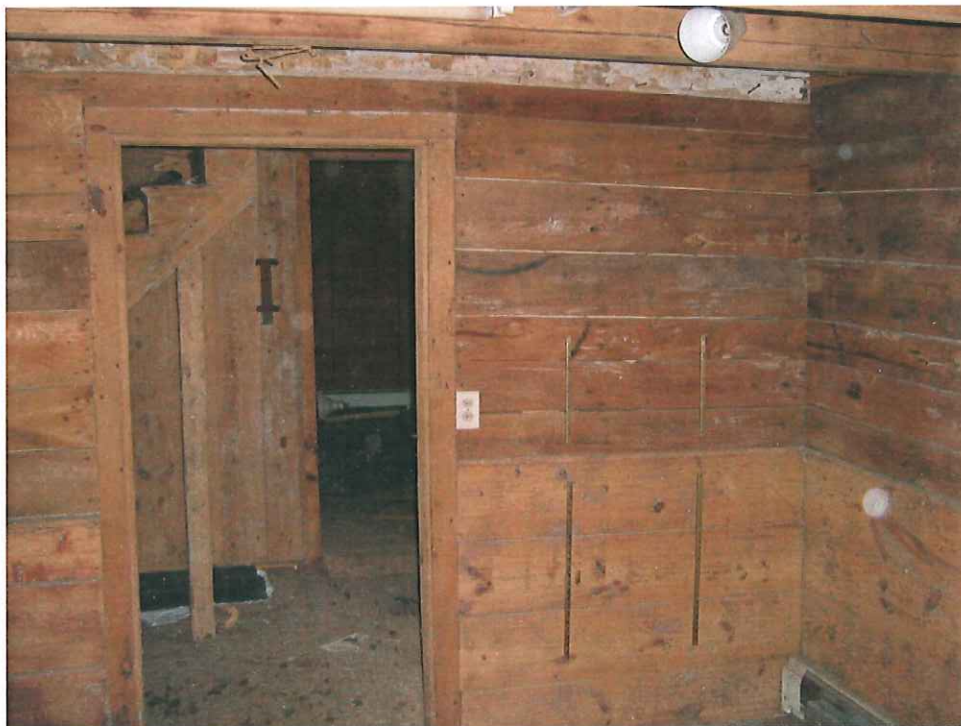
Photo 8: Room 102 facing north. The door casing and wainscoting appears to be original, but unfortunately have been sandblasted along with the ceiling. (11/27/12)

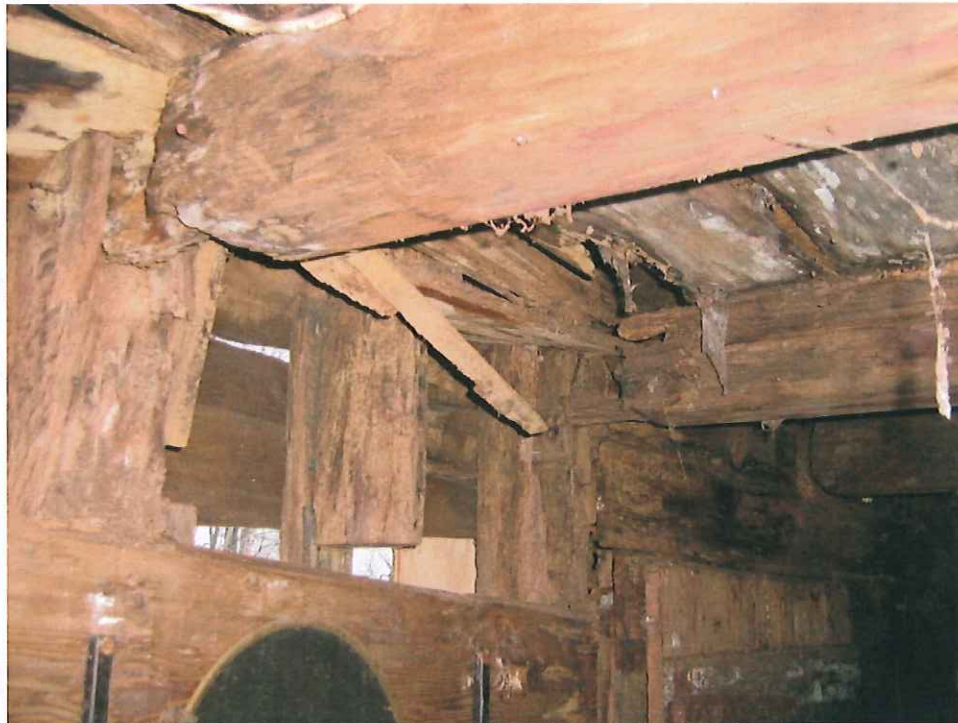
Photo 9: Condition of joists and wall framing at west side of Room 102. The condition of the framing is such that complete reconstruction of this wall is required. The cut off stud at center indicates the location of an earlier window. (11/27/12)

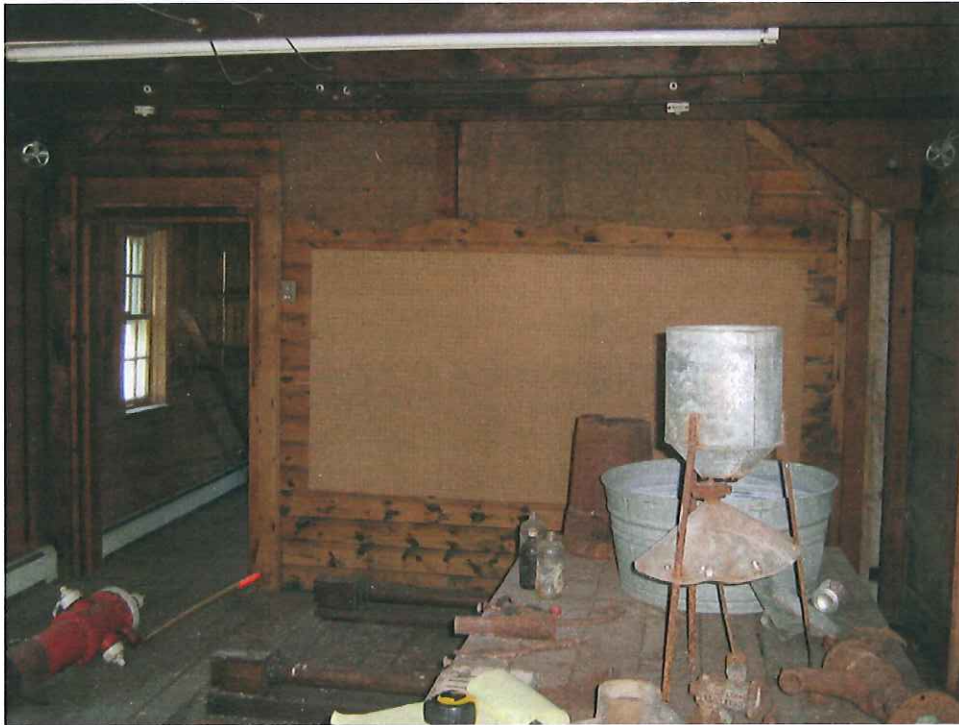
Photo 11: Room 103 facing east. This wall appears to have been the exterior wall of a building the size of Room 104 . In this room the south and east walls – previously painted exterior clapboard walls – have been sandblasted. (10/5/12)

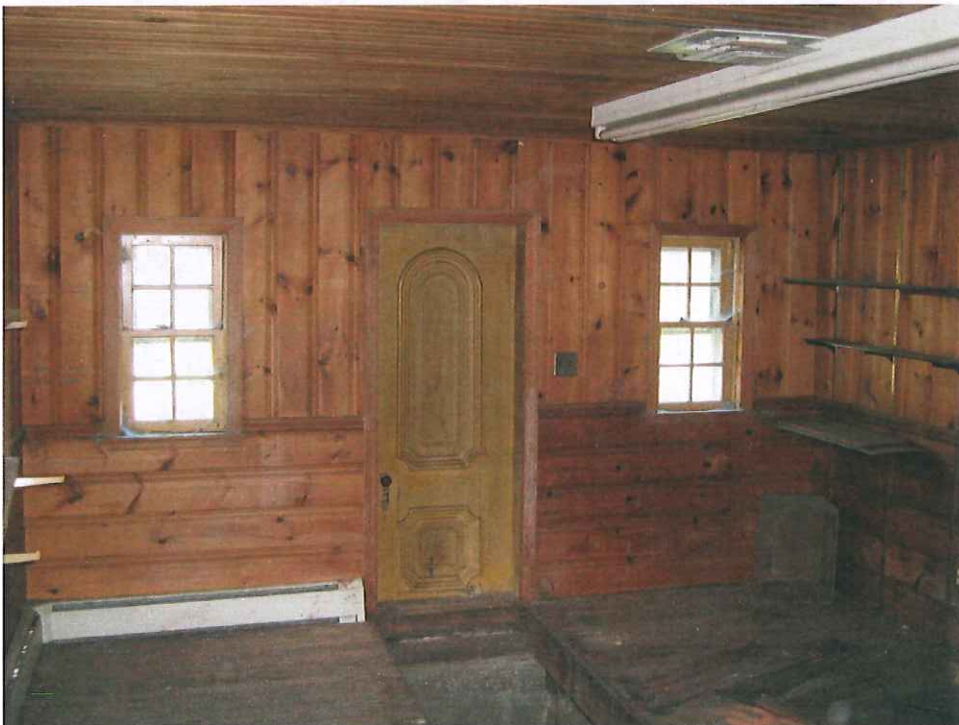
It appears that the next phase of construction, following the enclosure of Room 101, was the construction of Room 104. This is the only section of the building that is built over a basement, access to which is provide through a floor hatch immediately inside Door 102. The foundation of this section is stone with an area of concrete infill about two feet deep immediately below Door 102. This area of infill might be an indication of a low door opening cut through the foundation indicating a root cellar or ice house. The framing in this section is a combination of 2x framing

Photo 12: Room 104 facing east. Just visible within the open floor hatch is concrete infill in the foundation which might indicate the opening to an earlier ice house or root cellar over which this section was constructed. (10/5/12)

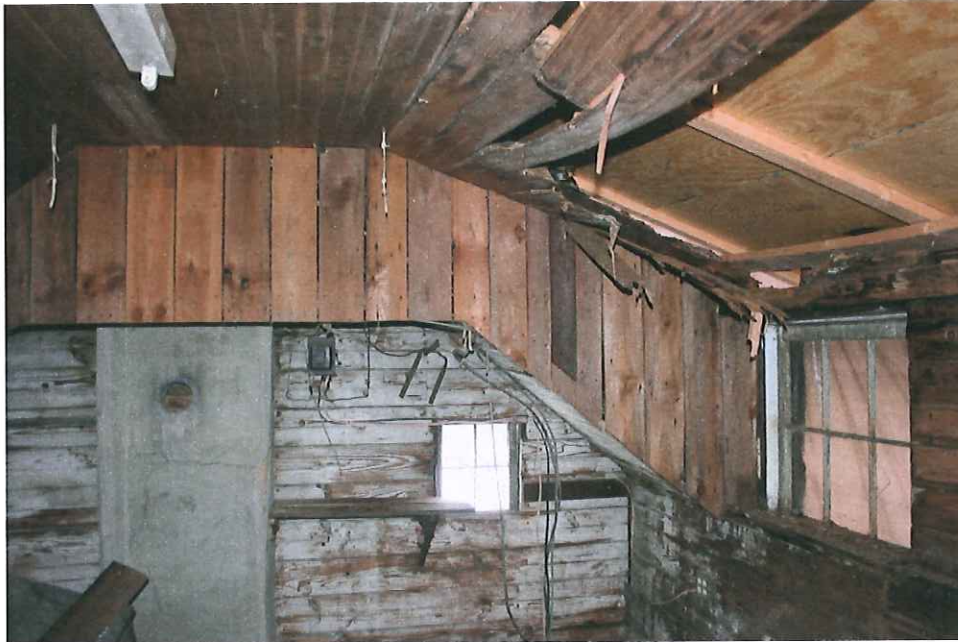
Photo 15: Room 201 facing south. Note temporary sheathing at dormer roof. (1/17/13)

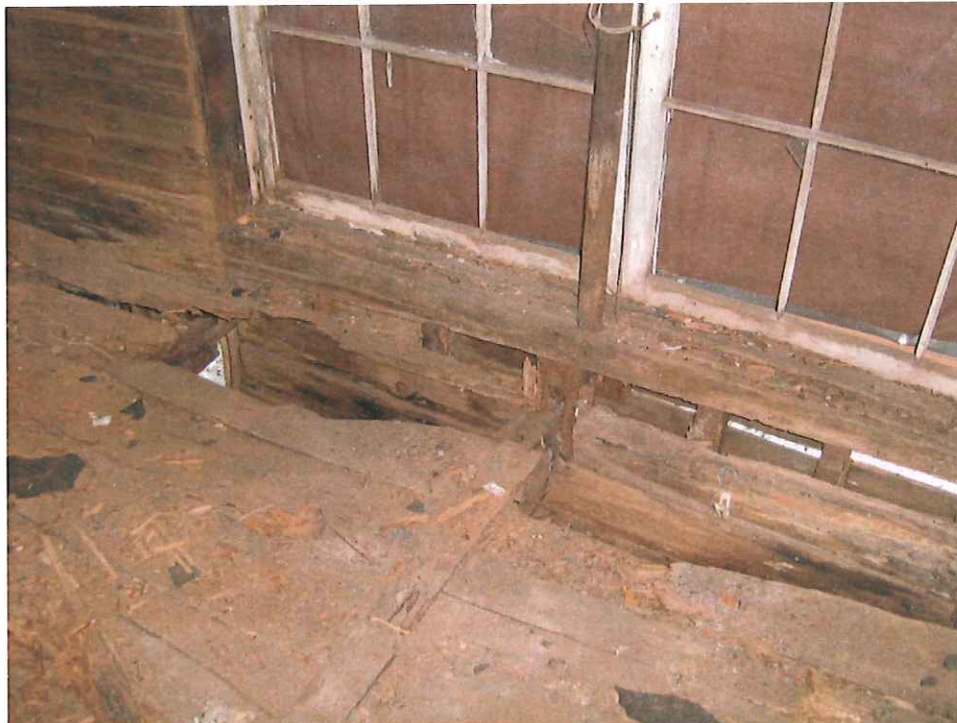
Photo 16: Condition of floor and joists inside large dormer casement. (11/27/12)

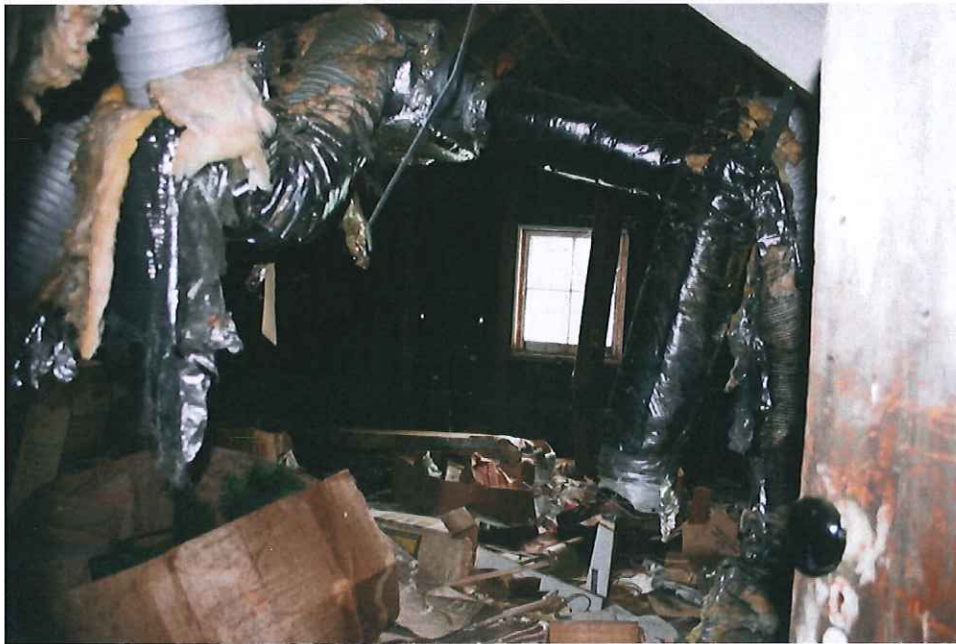
Photo 17: Debris at Room 202. (1/17/13)

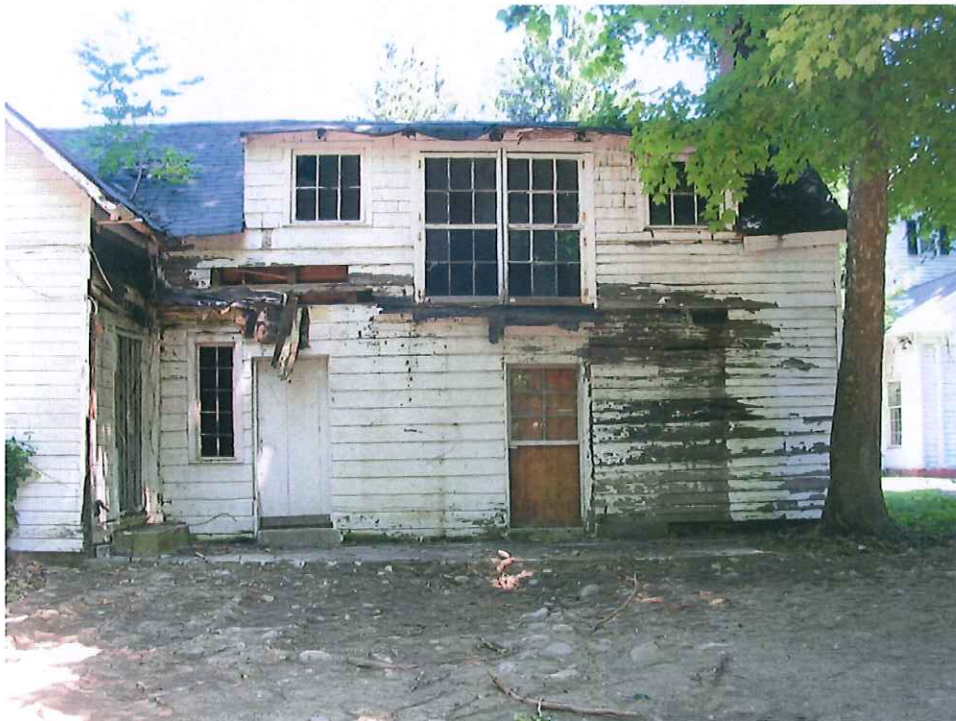
Photo 18: View of the west elevation showing the dormer and large casement window. The outline of a greenhouse and the corresponding concrete pad is also visible. (1/17/13)

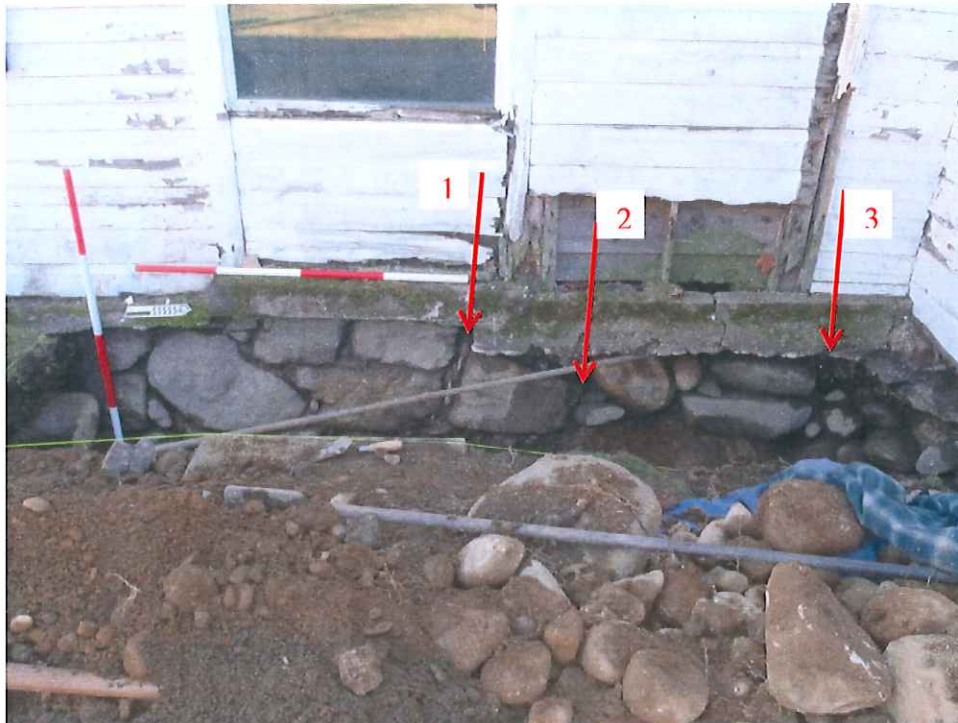
The above information points to the section of the building containing Rooms 103 and 202 as the last period of construction filling in the ell between the two earlier buildings. This section is constructed over a crawl space. The foundation is concrete with the exception of the very small area at the southeast inside corner connecting the foundations of the two earlier sections (visible in Photo 19) See also 1911 Map (Photo 21).

Photo 19: View of excavation unit along east wall of the south section. The original north exterior wall of the first build aligns with the left side of the window. Arrow 1 shows a possible joint in the foundation which may correspond the edge of a porch along the north elevation although the stone immediately to the right could have been included. The porch also could have extended to Arrow 3. To the right of Arrow 3 is the very hastily constructed foundation connecting the two earlier sections of the building. Please refer to the letter from Hunter Research dated 1/31/13 for further discussion. (12/18/12)

The large rectangular excavation unit was placed under the door sill in the eastern wall of the southern wing in order to examine the development of the basement foundation. The foundation was built on top of the glacial cobbles underlying the site, and had some discernible "seams" suggesting construction phasing. The first seam, a roughly vertical line that appears to delineate a well-made trimmed stone foundation (to the south) from a more informal boulder foundation (to the north), lies under the east-west joist lying midway between the sided exterior wall forming the south wall of the stairway hall within the southern wing, and the southern wall of the main, more-modern block (forming the north wall of the stairway hall).

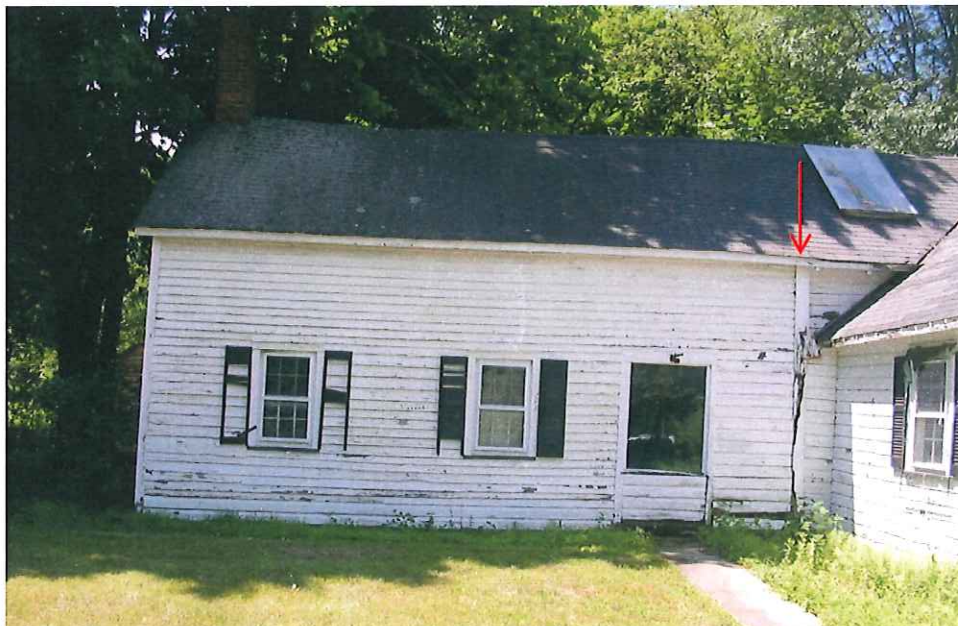
Photo 20: The rafter plate at this section is continuous to the red arrow which corresponds to Arrow 3 in Photo 19. (7/3/07)

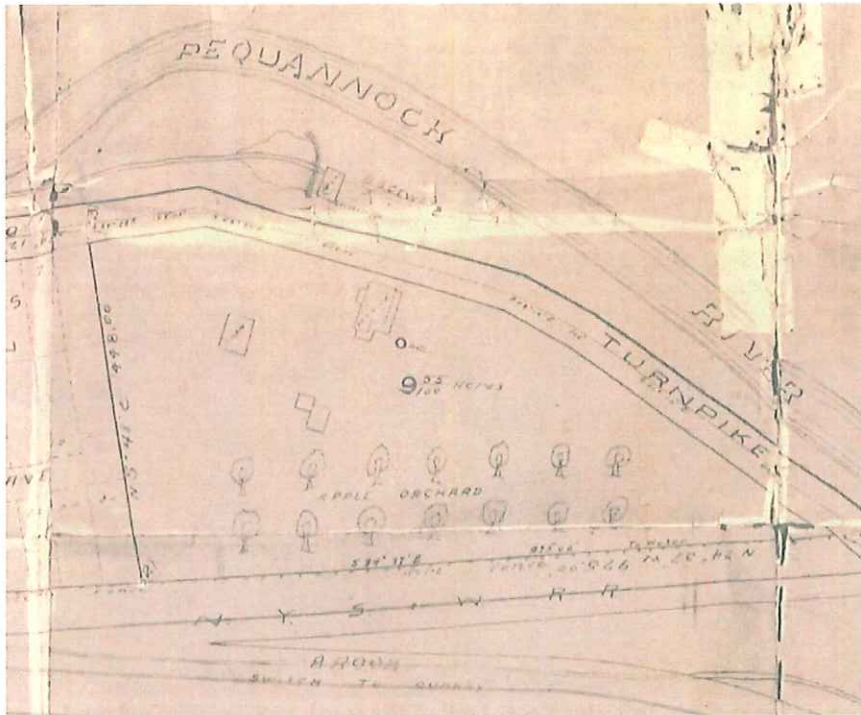
Photo 21: This 1911 Map shows the store building prior to construction of Room 103, which filled in the ell created by the two earlier sections.. (7/3/07)

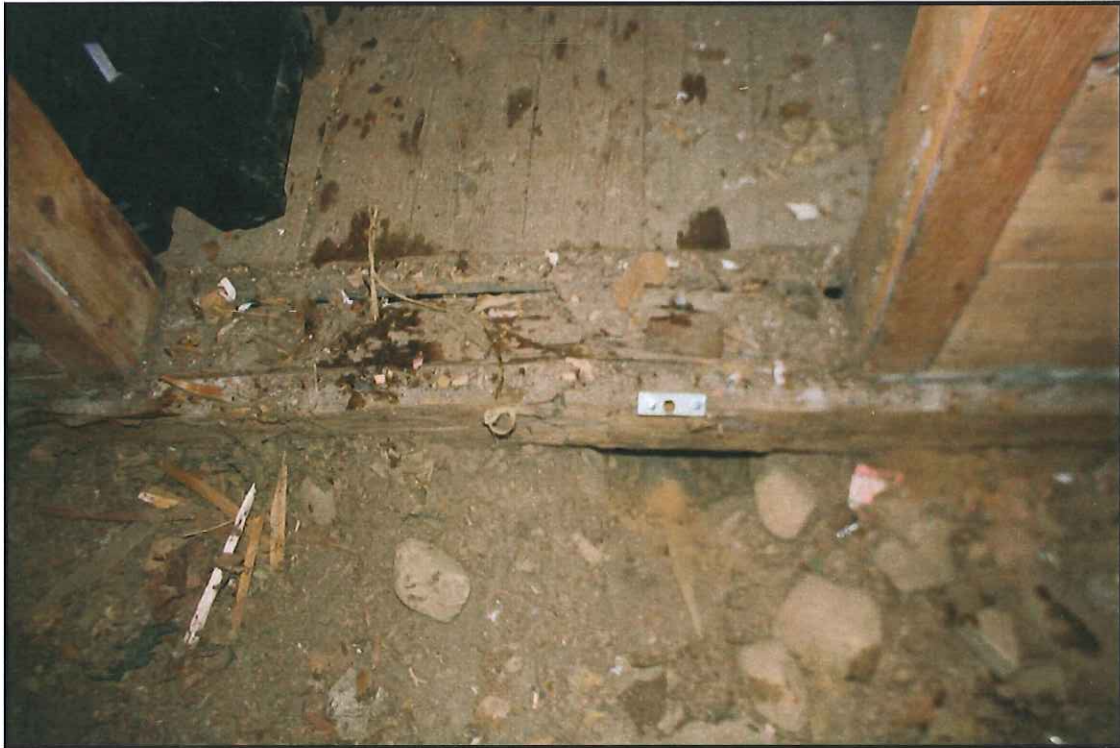
Sample #1, This sample was taken from a sill plate in the purportedly older section of the building on the west side. It was oak and had 137 rings. The edge of the timber was a bit battered. It may once have been a waney edge. The timber dated against the Northern New Jersey Master to give a date of 1845 for the final ring, but not very well. It dated against the Philly Master and the Monmouth Master to give a date of 1782 for the last ring, but even more weakly. Architectural details may help resolve the date of this timber (Figure 1).

Figure 1. The small silver rectangle is the tree-ring dating starting plate. It indicates the location of the first sample.

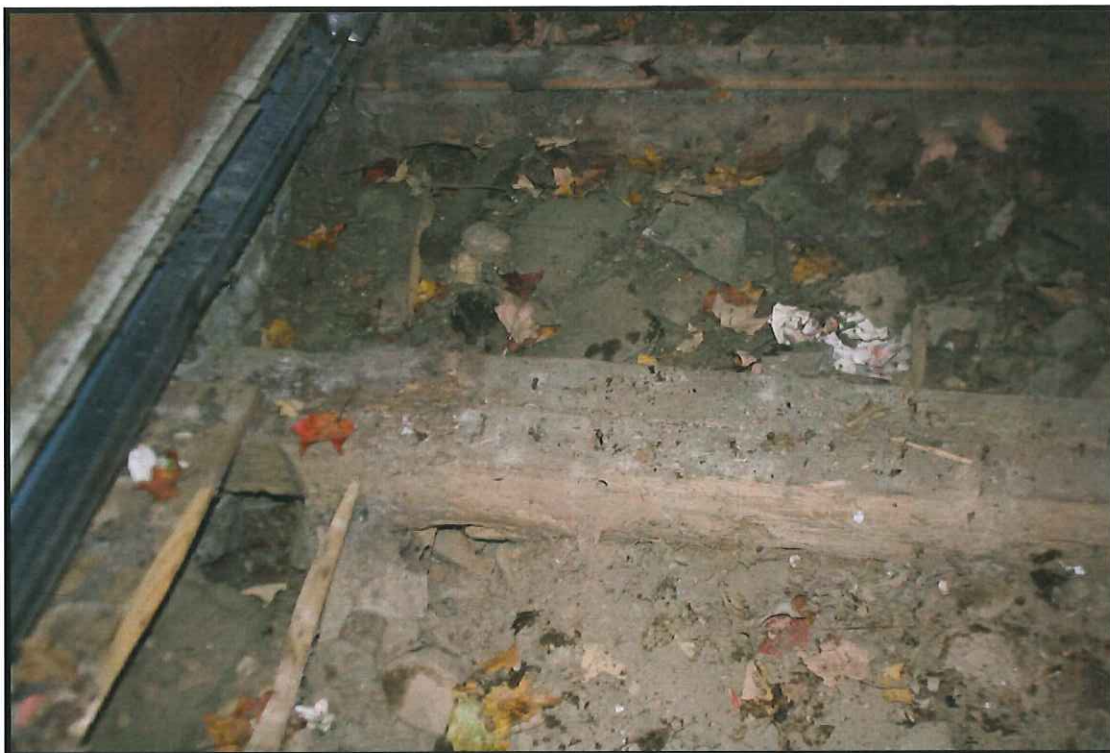
Sample #2. This sample was taken from the third floor joist south of door in the purportedly older section of the building. It had a waney edge but was not oak and had only 38 rings. It could not be dated (Figure 2).

Figure 2. The sample was taken from the center of this beam on the waney edge.

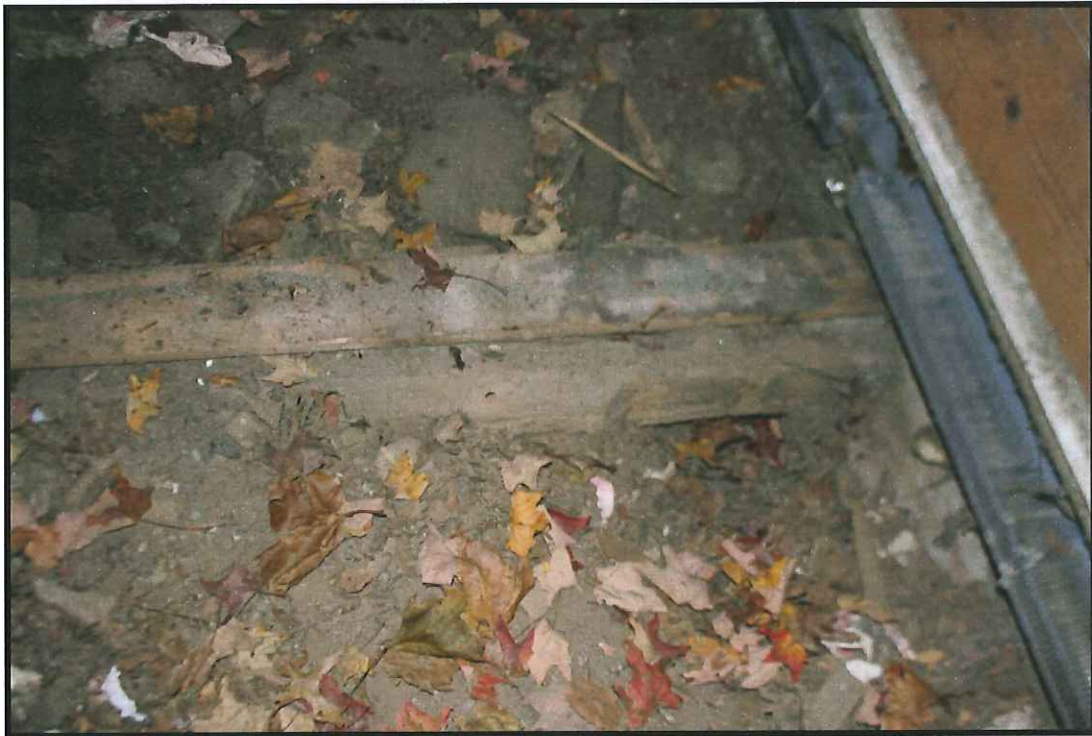
Sample #3. This sample was taken from the fourth joist south of door in what is purported to be the oldest part of the building. It had a waney edge and was not oak. The sample had 46 rings. It could not be dated.

Figure 3. This photo shows the sample location.

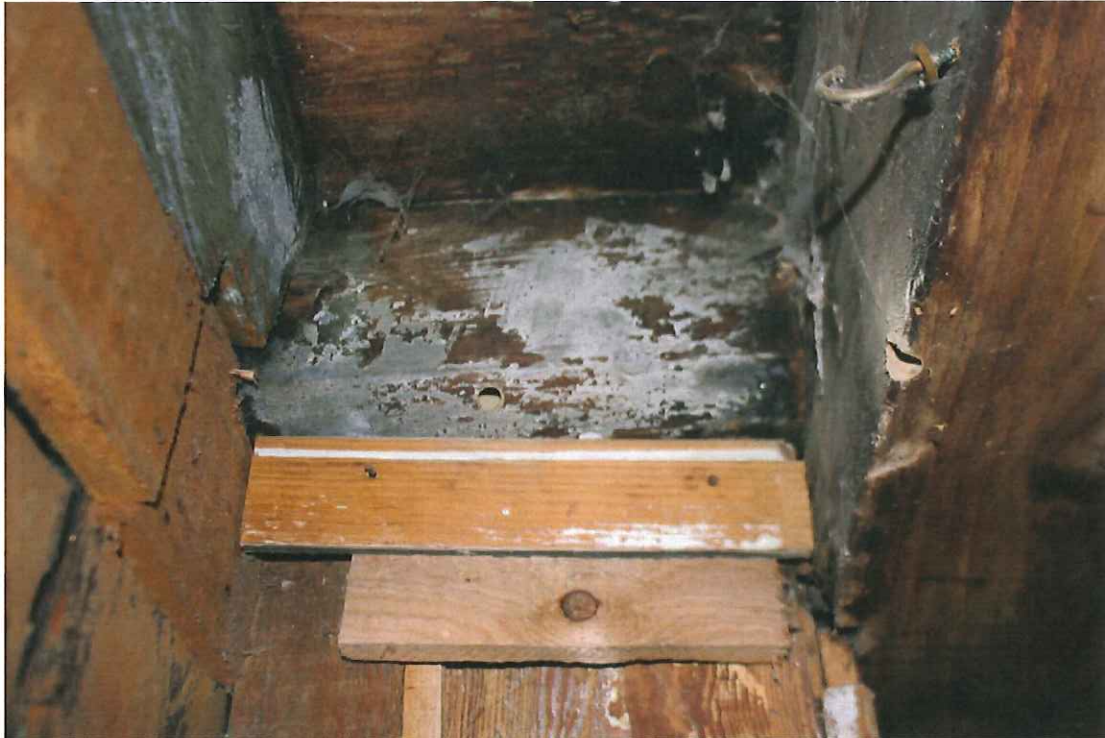
Sample #4. This sample was taken from a fireplace support on the east side of the fireplace. It had a waney edge. The timber was poplar. It had a waney edge but yielded only 61 rings (Figure 4).

Sample #5. This sample was taken from a fireplace support on the east side of the fireplace. It had a waney edge. The timber was poplar and the rings were indistinct. It could not be dated (see Figure 4).

Figure 4: Sample four is located in the center of the photograph and Sample Five is located to the right.

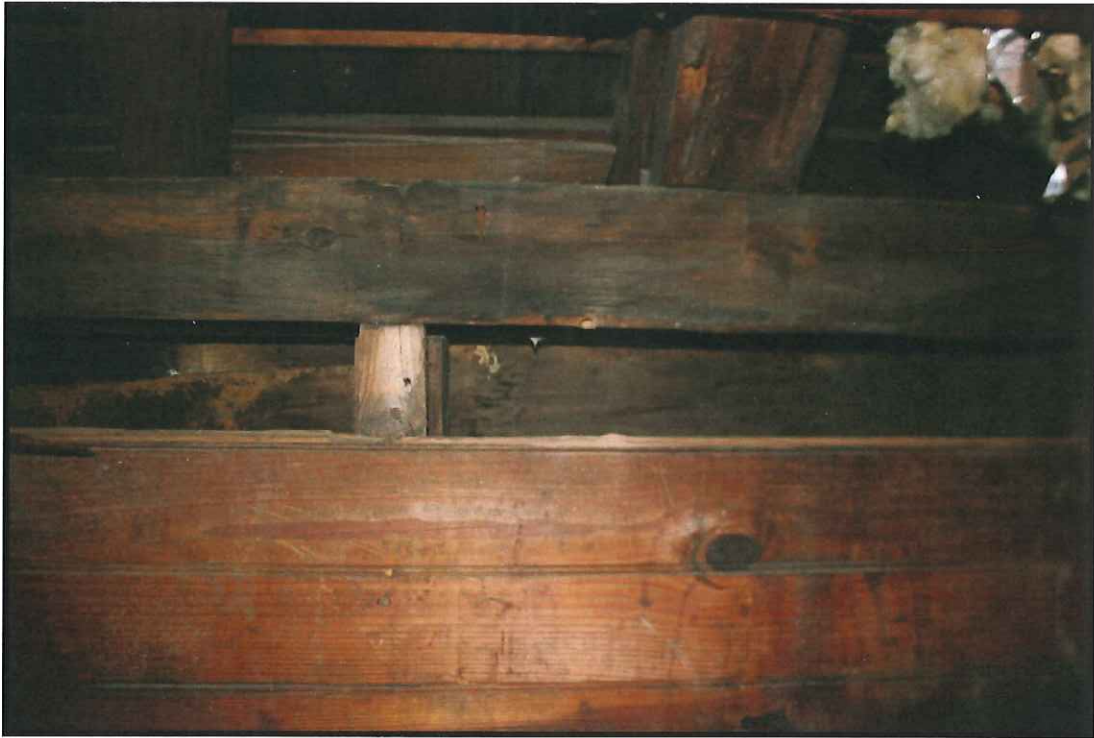
Sample #6. This sample was taken from the second floor rafter plate in the northeast corner of the building. The timber was not identified. It had 33 rings and could not be dated.

Figure 5: View showing sample six's location.
